MISCELLANEOUS PAPER NO. 4-520

FIELD TESTS OF AM3 LANDING MAT

May 1960

U. S. Army Engineer Waterways Experiment Station
CORPS OF ENGINEERS
Vicksburg, Mississippi

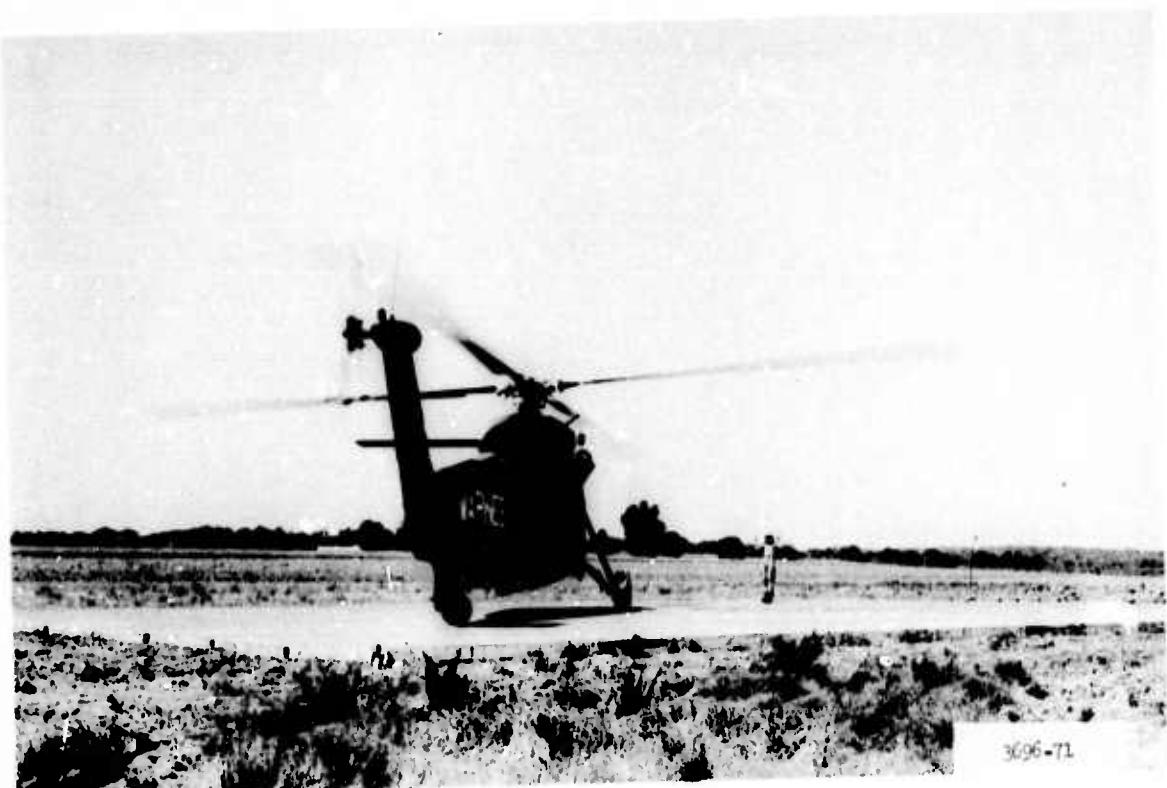
3696-71

Photograph 24. Taxiing operations on pad; gross aircraft weight, 10,000 lb

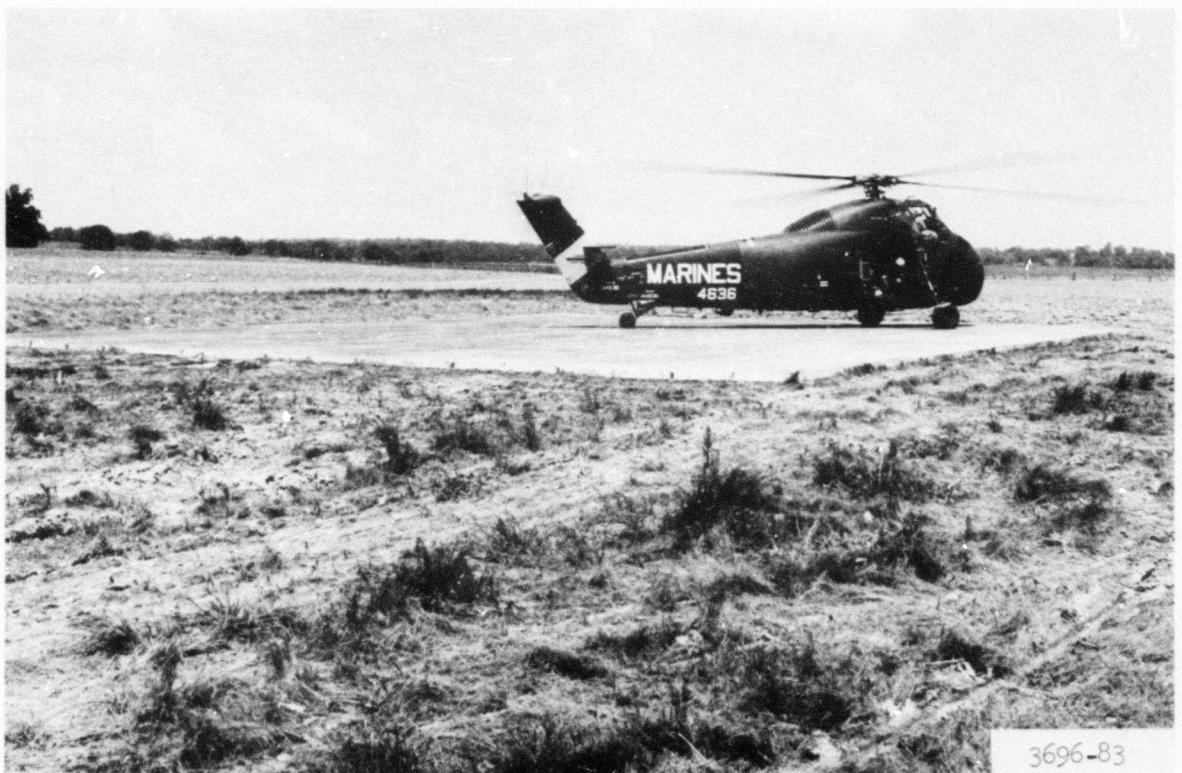
3696-83

Photograph 25. Helicopter on edge of pad after making a rolling landing across pad; gross aircraft weight, 12,000 lb

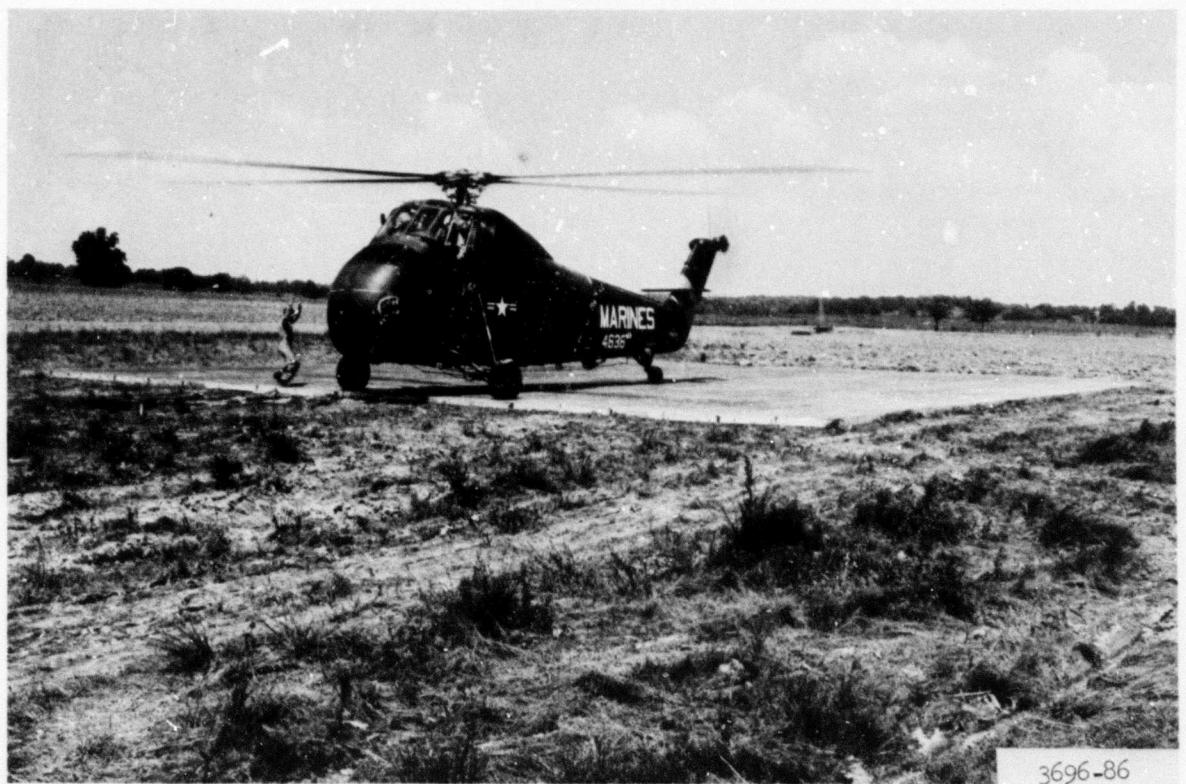
3696-86

Photograph 26. Taxiing operations with main load wheels approaching edge of pad (gross aircraft weight, 12,000 lb)

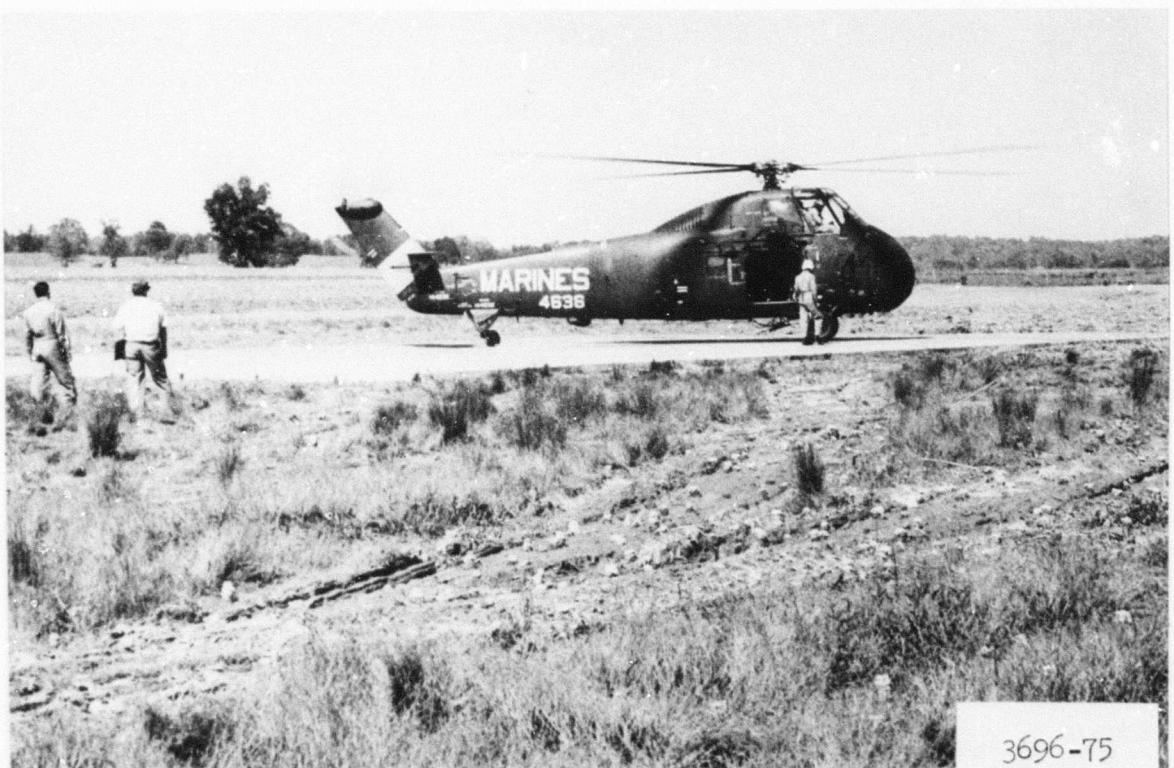
3696-75

Photograph 27. Tail wheel trafficking depressed area
shown in photograph 21

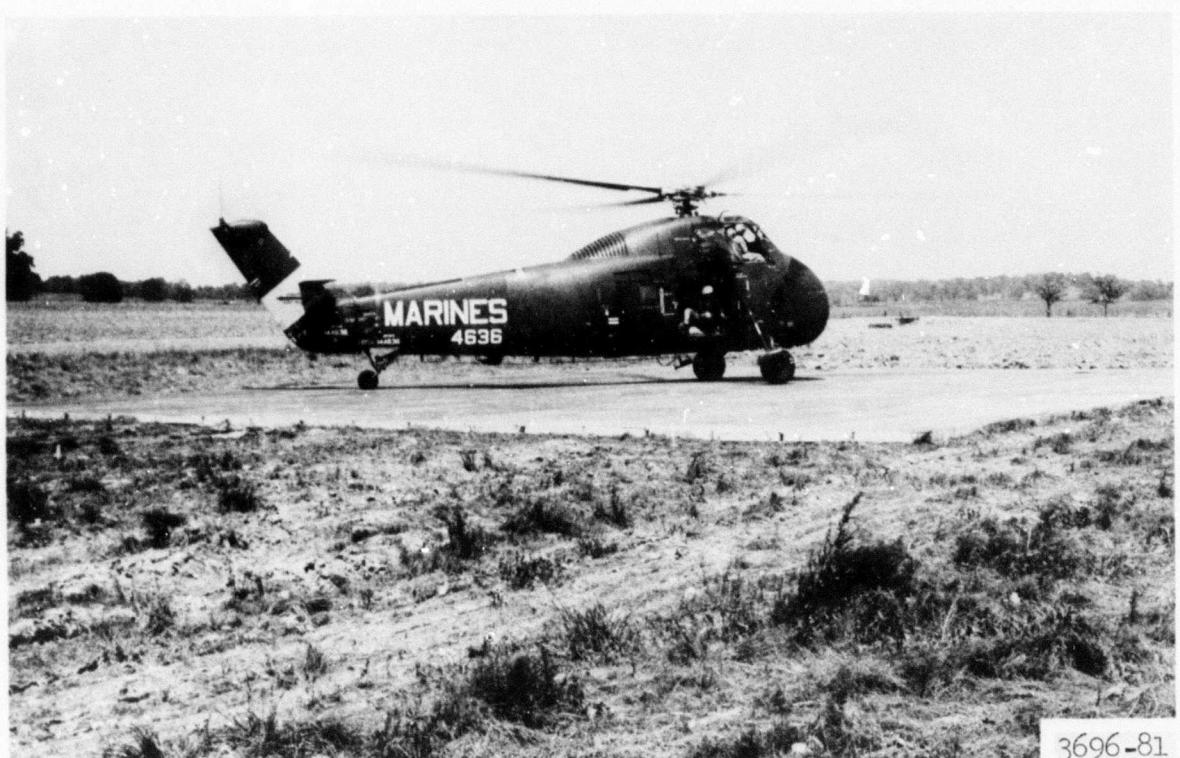
3696-81

Photograph 28. Main wheel trafficking depressed area
shown in photograph 21

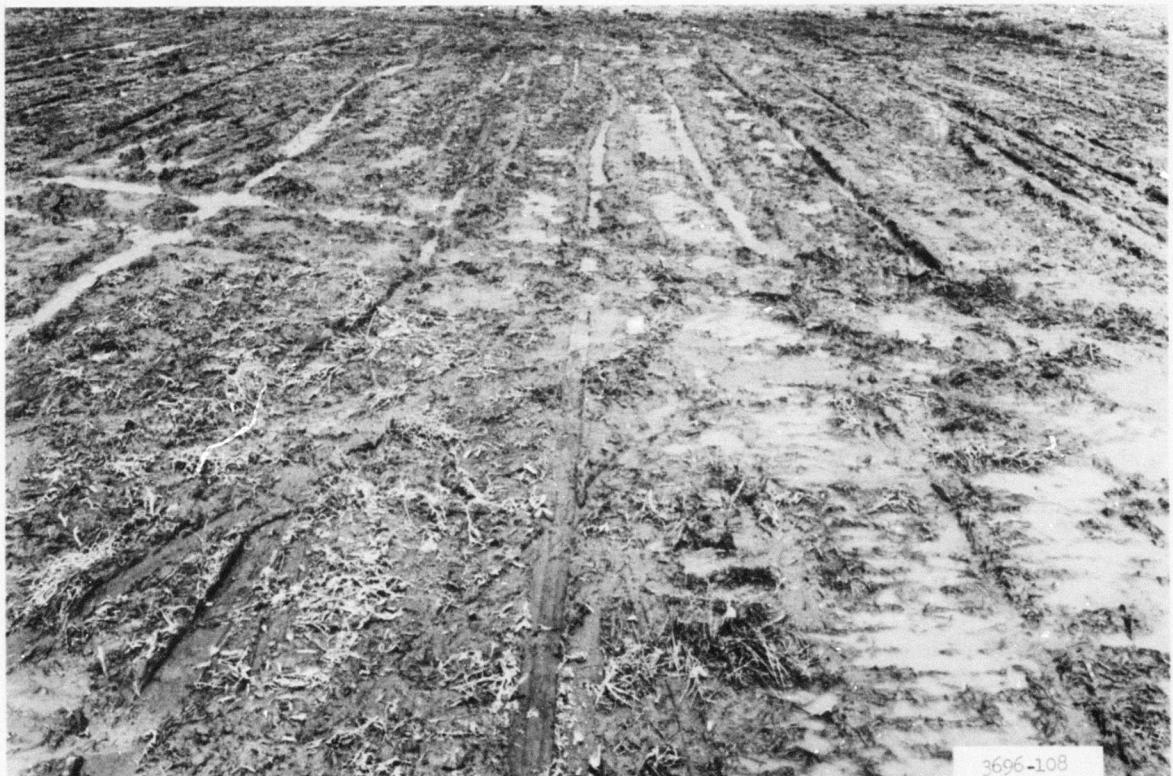
3696-108

The condition of the marsh after the pad was removed is shown in photograph 29.

Photograph 29. Marsh immediately after pad removal

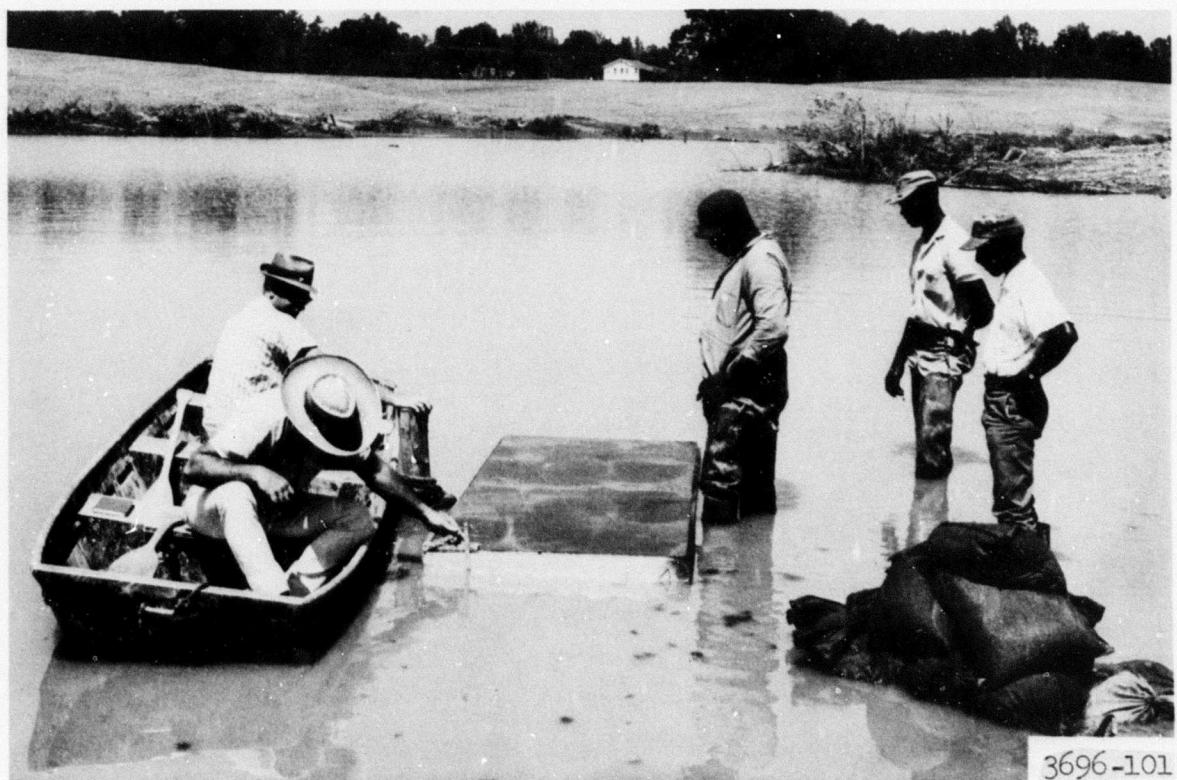
3696-101

Photograph 30. Panel floating with 3-in. freeboard
after being submerged for 10 days

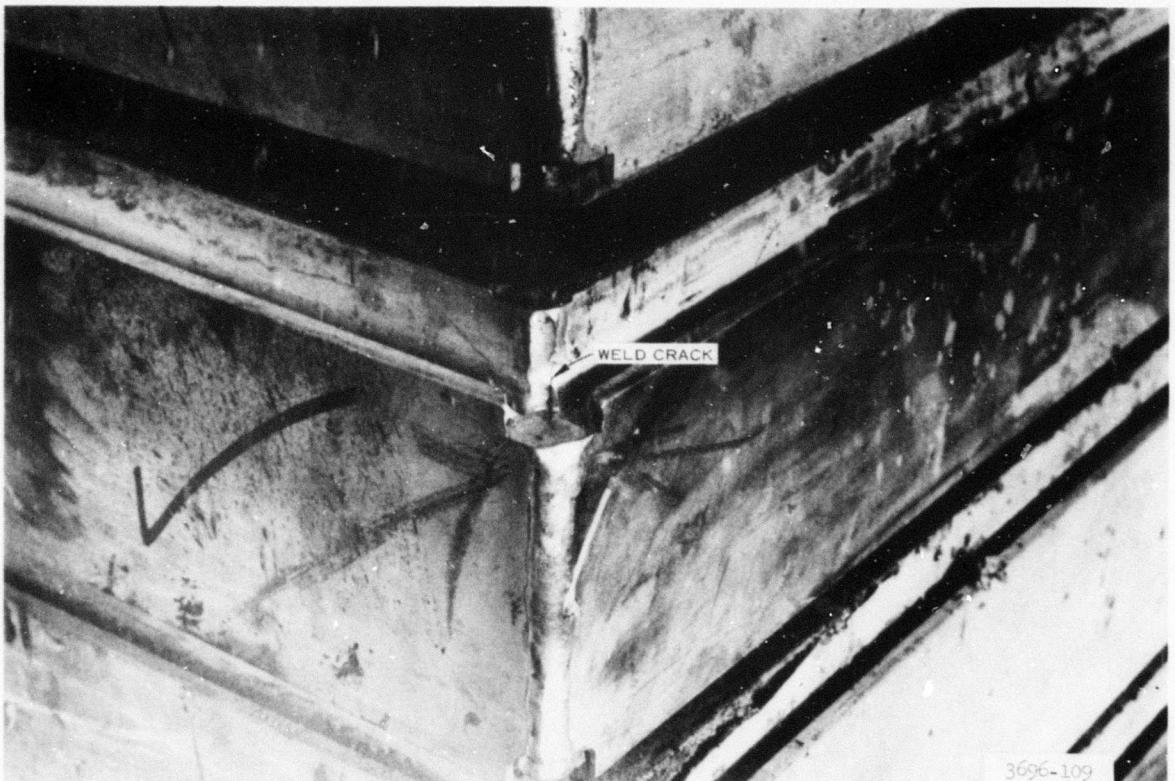
27. In Phase I tests, it was evident that some of the panels were absorbing water. One panel which weighed 183 lb prior to the test and 267 lb after 7 days on the pond was selected for a submergence test to determine how much additional water it would absorb. This panel was completely submerged with 750 lb of ballast for 10 days. After the ballast was removed, the panel floated to the surface and had an average of 3 in. of freeboard around its edges (photograph 30). Its weight had increased to 292 lb, a gain of 25 lb and a total gain of 109 lb. It is believed that hairline cracks in the corner welds of the panel (photograph 31) allowed water to seep into the core. About 25 to 30 percent of the panels had such cracks; these panels were easily detected as water ran out of the cracks when one end of a panel was elevated.

- d. During helicopter operations in Phase I tests, minor cracks developed in the welded corner joints of the extruded aluminum connectors which permitted an average of 30 lb of water per panel to enter the cores of the panels. Polyurethane foam in the cores somewhat restricted the amount of water absorption and prevented the panel from sinking.

Photograph 31. Hairline crack in upper portion of panel corner which allowed water to enter the core

- a. The AM3 design be modified to reduce panel size (thus reducing weight) and to improve the connectors.
- b. A primer be applied to the panels to eliminate glare once the antiskid compound is removed, and an improved antiskid coating be used that is unaffected by exposure to water.
- c. A membrane be used between the AM3 mat and cohesive soil if it is desired that the mat float when the area is inundated or if the mat is to be removed for reuse.

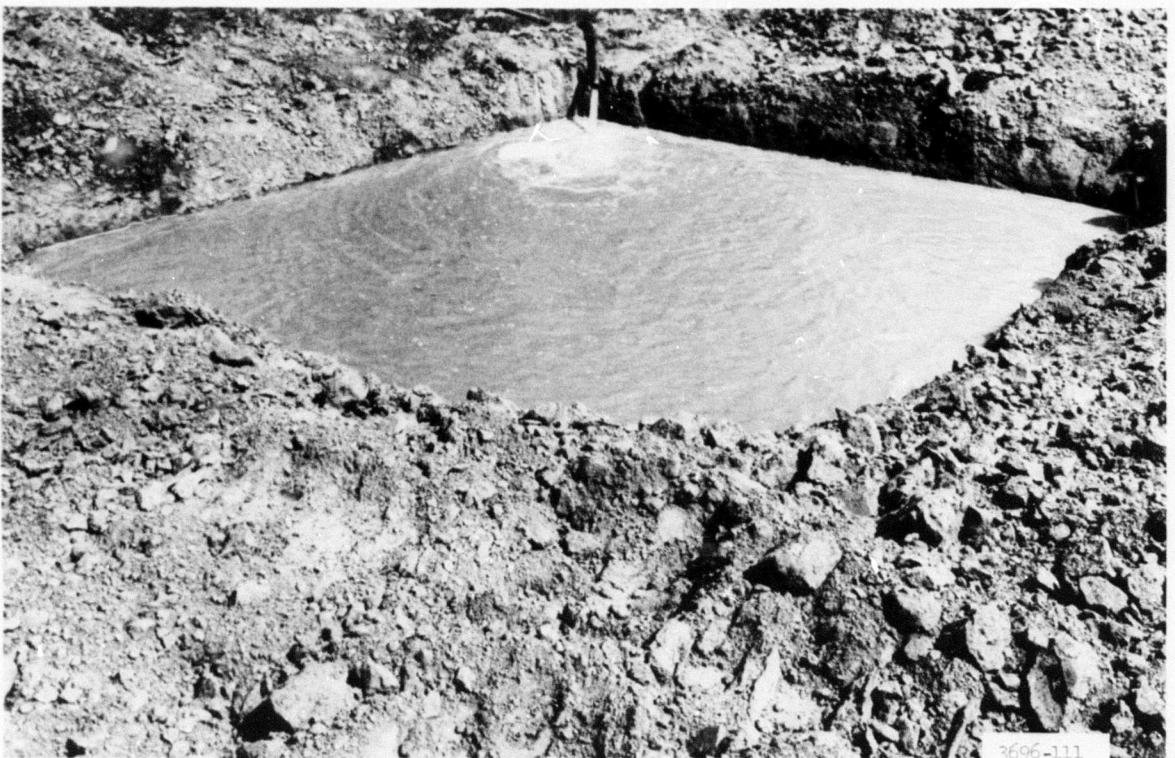
Photograph 32. Pit being flooded in preparation for adhesion tests

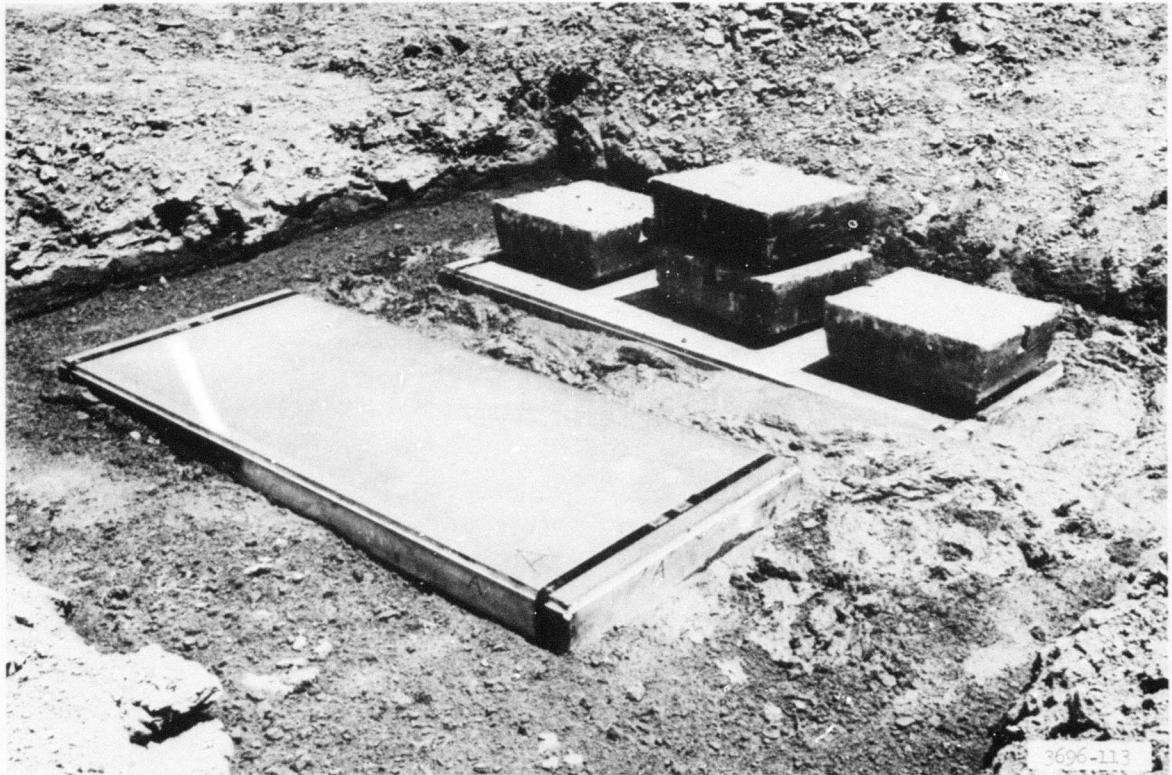
The submergence and adhesion tests indicated that panels would adhere to clay soil when submerged under certain load conditions, and that the use of a membrane beneath the pad would alleviate this adhesion.

Photograph 33. Panels in marsh pit with 8000-lb load on one panel

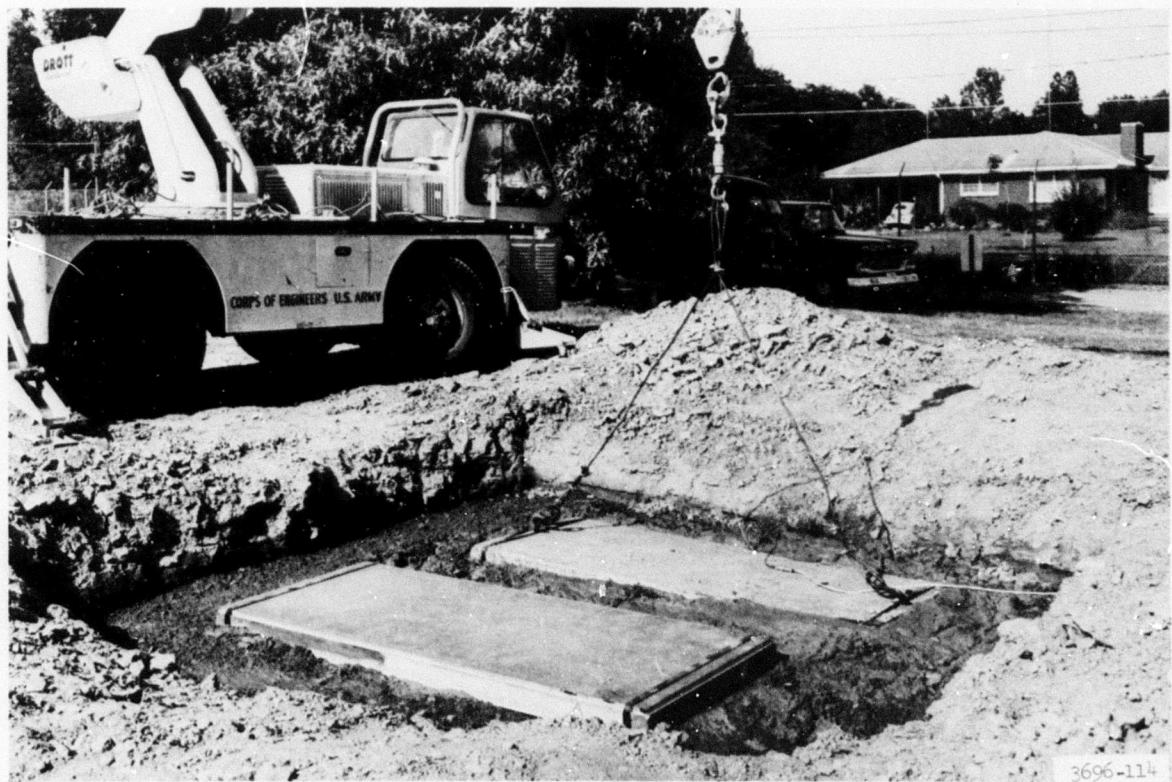
29. In the first test, one unloaded panel and one panel loaded to 8000 lb were placed in the pit (photograph 33). After 3 hr, the weight was removed from the loaded panel and an attempt was made to pull the panels from the mud. An overhead crane equipped with a dynamometer measuring the pull was used for the lifting. The unloaded panel was pulled out with a 450-lb pull. On the first attempt to pull the panel which had been loaded, the steel straps around the panel broke at 2000-lb pull without

moving the panel (photograph 34). Another attempt was made the next day, and the panel was removed with a 4400-lb pull. The unloaded panel was again placed in the pit; this time a 475-lb pull was required to remove it. A third panel was loaded to 8000 lb for 4 hr and then unloaded. A 1725-lb force was required to pull one end of this panel out of the muck.

Photograph 34. Attempt being made to remove panel from muck just prior to steel straps breaking
